URGENT Field Safety Notice

Philips Azurion and Allura with 1 Phase UPS
Potential Loss of System Functionality

July 2025

Reference: 2024-IGT-BST-009: Philips Azurion and Allura with 1 Phase UPS
Potential Loss of System Functionality

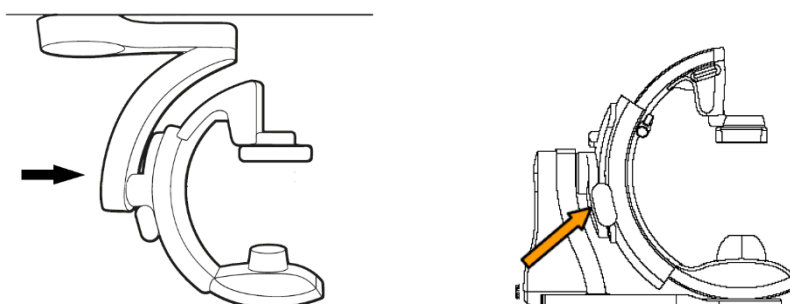
Figure 1: Location of the System identification label

The Product Number and Product Name can be found on the System Identification Label (Figure 1).
