**FSN Ref:** 2025-FSN-000103

**Date:** 2025-07-03

**URGENT Field Safety Notice**  
**Risk of Automated Impella Controller (AIC) Intermittent Impella**  
**Detection Issue.**

| 1. Information on Affected Devices* | |
|---|---|
| | All Automated Impella Controller (AIC) |

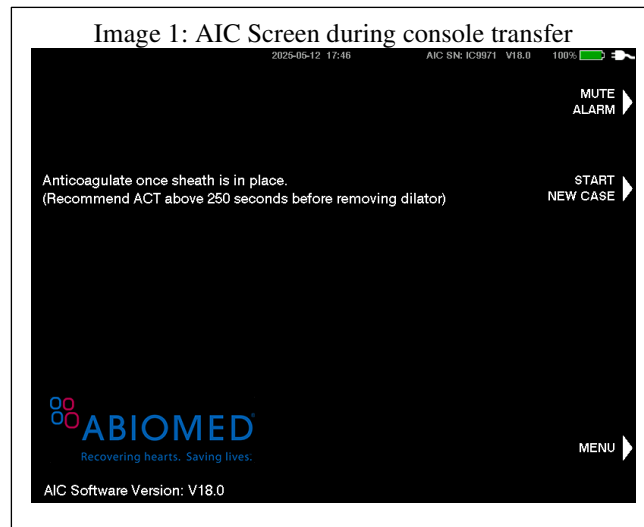
During console-to-console transfer, if the pump is not detected once connected to the AIC, the AIC screen in Image 1 remains and does not advance.

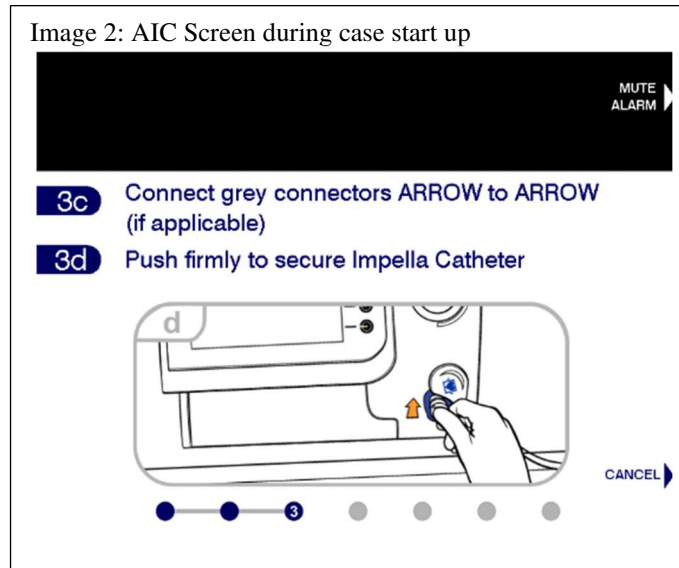
During case start, if the pump is not detected once connected to the AIC, the AIC screen in Image 2 remains and does not advance.

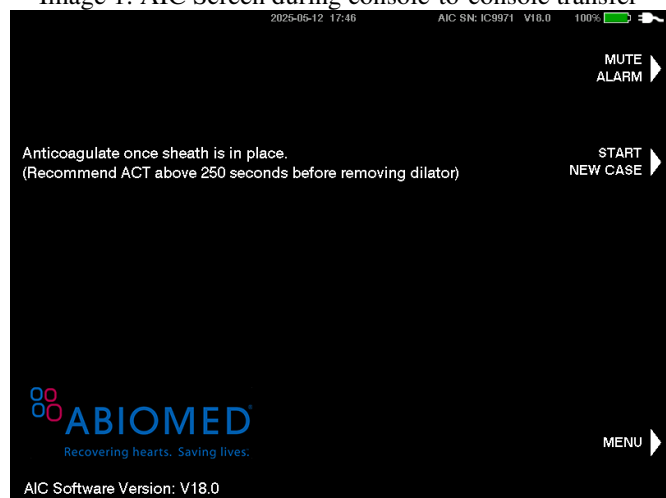
Image 1: AIC Screen during console-to-console transfer

The AIC screen in Image 1 remains for more than 20 seconds and does not advance after connecting the pump to the receiving console:

- Scenario 1: If no alarm on the previous console, then immediately switch the pump to the previous console to restore support to the patient.
- Scenario 2: If the previous console displays an alarm message, then switch to a different console if available. If a different console is not available proceed to scenario 3.
- Scenario 3: If the previous console displays an alarm message, but a different console is not available, then re-start the case on the receiving console (console that does not advance from Image 1 before attempting to re-connect a pump):
  1. unplug the pump
  2. re-start the console
  3. press START NEW CASE from the startup screen

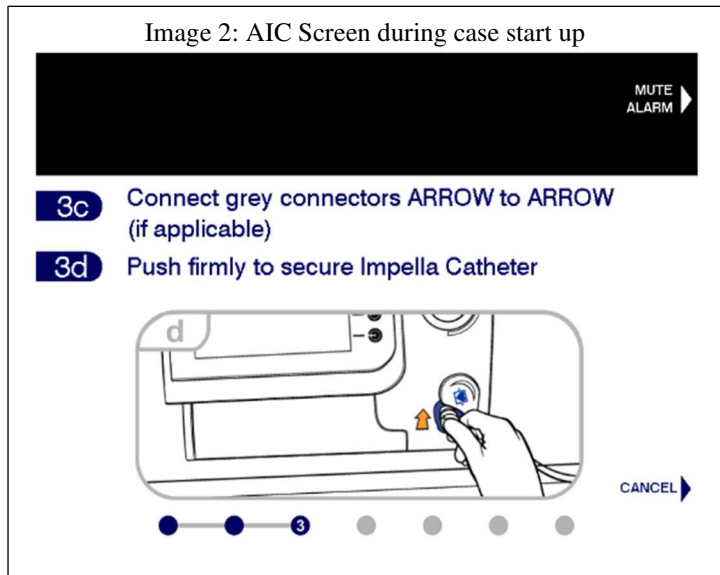
The AIC screen in Image 2 remains for more than 20 seconds after connecting the pump and does not progress to indicate “Detecting Impella”:

- Option 1: re-start the case:
  - unplug the pump
  - re-start the console
  - press START NEW CASE from the startup screen
- Option 2: switch the pump to a different console if available.
