## Update – Field Safety Notice

### Multiva 1.5T

Gradient Coil component failure may act as a heat source with potential to produce smoke and/or fire.

Jun 23, 2025

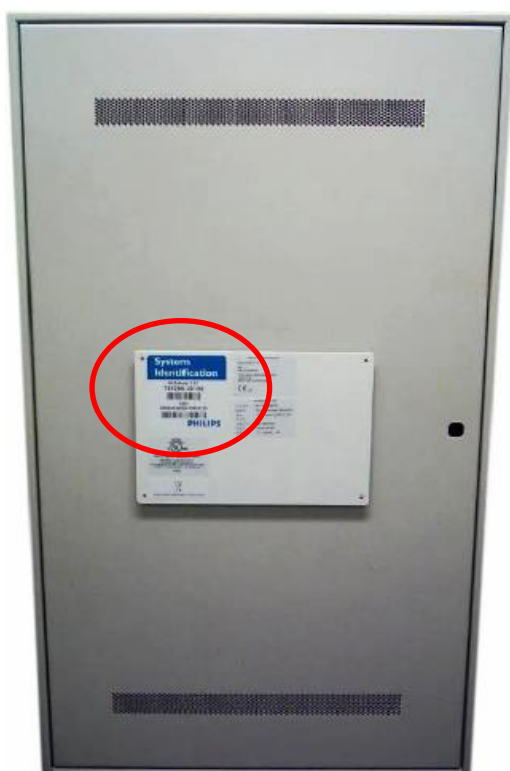
*Figure 1: Front door of gMDU*

- 3.1. Enter the Technical Room
- 3.2. Locate the general Mains Distribution Unit (gMDU) and Liquid cooling cabinet (LCC)
- 3.3. The system label is located on the front door of the gMDU (see figure 1) or LCC (see figure 2)
- 3.4. Locate the serial number on the system identification label (see figure 3)

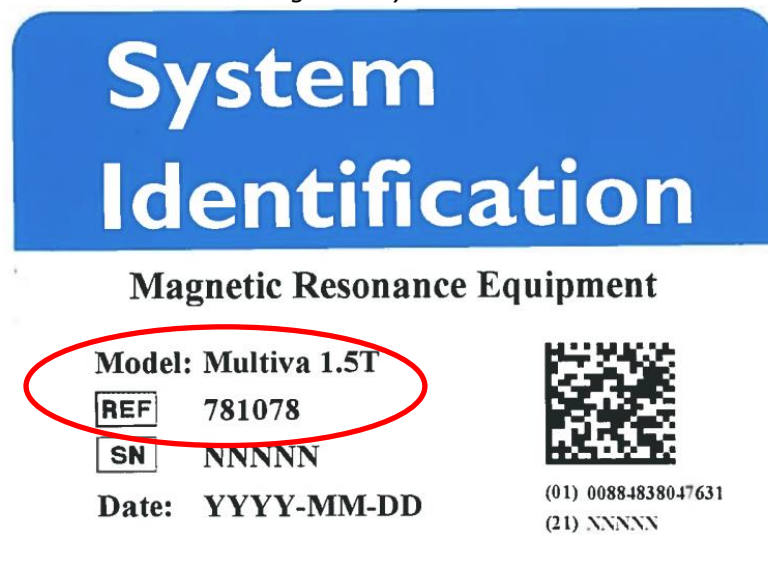
Figure 3: system label

The affected Multiva 1.5T MR Systems including product number (REF), name (Model) listed in below table. Figure 3 illustrates the location of the product number (REF) and name (Model) on the system label.

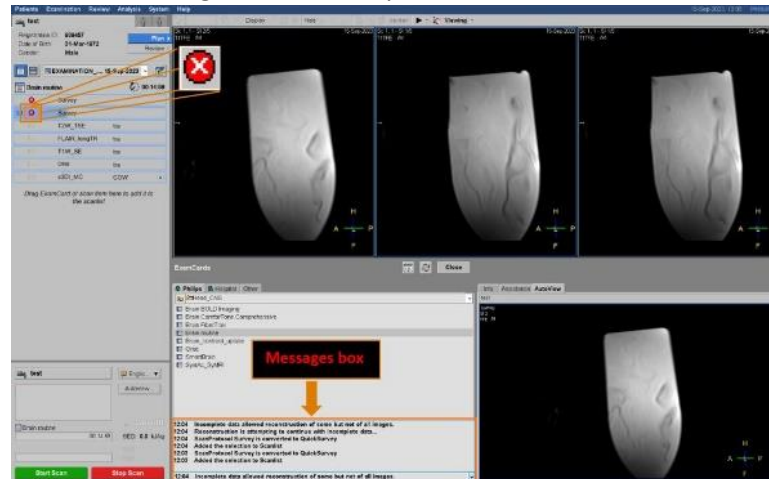
Figure 5. UI example SW Version R5.

- 4.3. When scan aborts occur the symbol is shown and applicable messages are presented in the message box (see Figure 5 example)
  - 4.3.1. Check the status of the error messages in the User Interface (UI) screen. Click to expand the message box in case previous messages are hidden, see orange box in Figure 5 below. If possible, correct the issue that is relevant to the error shown, and continue scanning, for example:
    - "RF door must be closed while performing scan. Scan aborted."
    - "Patient support is moved while scanning, scan stopped."
    - "Coil A (or B) failure, coil disconnected?"

- 4.3.2. If, after a scan abort, one of the following conditions occur five times in a row stop scanning immediately and contact Philips Service to describe the problem:

- If there is no error message in the message box
  - If the error message meaning is not clear
- 4.3.3. If the error message “Gradient amplifier Rack Fault” is received two times in a row, or if the error message “Gradient amplifier Rack Fault” is preceded or followed by an aborted scan with no message, then stop scanning immediately and contact Philips Service to describe the problem.

- 4.3.4. If you encounter any of these conditions described in 4.3.2 or 4.3.3 do not attempt any additional/further scans, including without limitation do not attempt any phantom scanning until your system has been checked and released by a Philips Service representative.

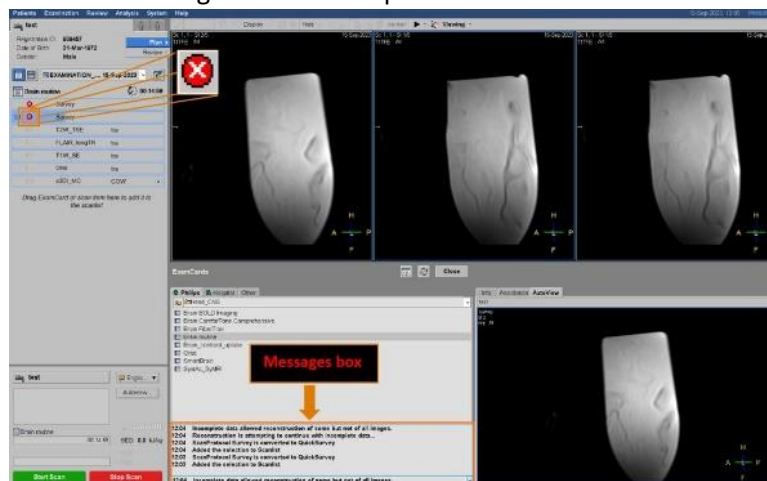
Figure 5. UI example SW Version R5.

- 4.3. When scan aborts occur the symbol is shown and applicable messages are presented in the message box (see Figure 5 example)
- 4.3.1. Check the status of the error messages in the User Interface (UI) screen. Click to expand the message box in case previous messages are hidden, see orange box in Figure 5 below. If possible, correct the issue that is relevant to the error shown and continue scanning, for example:
- “RF door must be closed while performing scan. Scan aborted.”
  - “Patient support is moved while scanning, scan stopped.”
  - “Coil A (*or B*) failure, coil disconnected?”.

- 4.3.2. If, after a scan abort, one of the following conditions occur five times in a row stop scanning immediately and contact Philips Service to describe the problem:
  - If there is no error message in the message box
  - If the error message meaning is not clear
- 4.3.3. If the error message “Gradient amplifier Rack Fault” is received two times in a row, or if the error message “Gradient amplifier Rack Fault” is preceded or followed by

an aborted scan with no message, then stop scanning immediately and contact Philips Service to describe the problem.

- 4.3.4. If you encounter any of these conditions described in 4.3.2 or 4.3.3 do not attempt any additional/further scans, including without limitation do not attempt any phantom scanning until your system has been checked and released by a Philips Service representative.
