## **URGENT Field Safety Notice**

### **Philips Allura R8.2.x System**

Software issue potentially resulting in loss of imaging (X-ray) functionality

4 JULY 2025

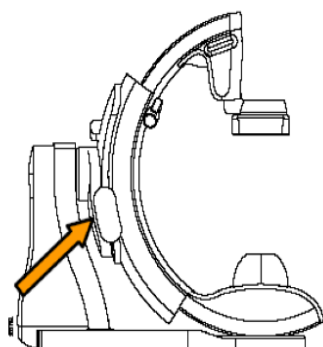
Figure 1- System Identification Label

The System Product Name and Model Number can be found on the System Identification Label located on the System stand (Figure 1). The software version of the Philips Allura systems can be identified during start-up (Figure 2).
