## Field Safety Notice

### Philips MR Systems

Gradient Coil component failures may act as a heat source with potential to produce smoke and/or fire.

30 JUNE 2025

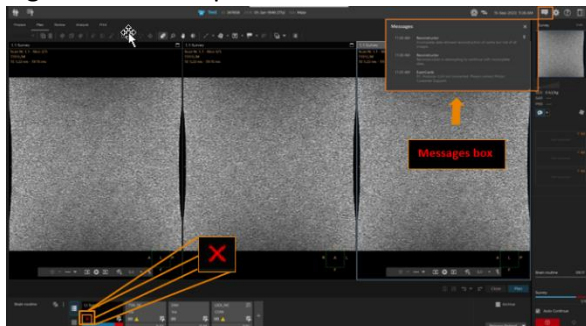
Figure 5. UI example SW Version R11.

- 4.3. When scan aborts occur the symbol is shown and applicable messages are presented in the message box (see Figure 5 and Figure 6 examples)
  - 4.3.1. Check the status of the error messages in the User Interface (UI) screen. Click to expand the message box in case previous messages are hidden, see orange box in Figure 5 and Figure 6 below. If possible, correct the issue that is relevant to the error shown and continue scanning, for example:
    - “RF door must be closed while performing scan. Scan aborted.”

- “Patient support is moved while scanning, scan stopped.”
- “Coil A (or B) failure, coil disconnected?”.

- 4.3.2. If, after a scan abort, one of the following conditions occur five times in a row stop scanning immediately and contact Philips Service to describe the problem:

- If there is no error message in the message box
  - If the error message meaning is not clear
- 4.3.3. If the error message “Gradient amplifier Rack Fault” is received two times in a row, or if the error message “Gradient amplifier Rack Fault” is preceded or followed by an aborted scan with no message, then stop scanning immediately and contact Philips Service to describe the problem.

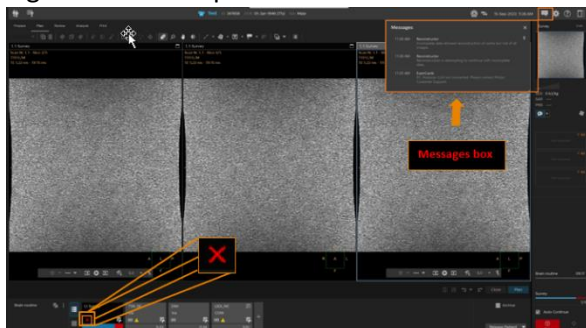
Figure 5. UI example SW Version R11.

- 4.3. When scan aborts occur the symbol is shown and applicable messages are presented in the message box (see Figure 5 and Figure 6 examples)
  - 4.3.1 Check the status of the error messages in the User Interface (UI) screen. Click to expand the message box in case previous messages are hidden, see orange box in Figure 5 and Figure 6 below. If possible, correct the issue that is relevant to the error shown and continue scanning, for example:
    - “RF door must be closed while performing scan. Scan aborted.”
    - “Patient support is moved while scanning, scan stopped.”
    - “Coil A (or B) failure, coil disconnected?”.

- 4.3.2 If, after a scan abort, one of the following conditions occur five times in a row stop scanning immediately and contact Philips Service to describe the problem:
  - If there is no error message in the message box
  - If the error message meaning is not clear
- 4.3.3 If the error message “Gradient amplifier Rack Fault” is received two times in a row, or if the error message “Gradient amplifier Rack Fault” is preceded or followed by an aborted scan with no message, then stop scanning immediately and contact Philips Service to describe the problem.
- 4.3.4 If you encounter any of these conditions described in 4.3.2 or 4.3.3 do not attempt any additional/further scans, including without limitation do not attempt any phantom scanning until your system has been checked and released by a Philips Service representative.
