Change Healthcare Canada Company 10711 Cambie Road Richmond, BC Canada V6X 3G5

Urgent Field Safety Notice

December 2024

Re: Editing Medication Information May Lead to Discrepancies in Procedure Medication Data

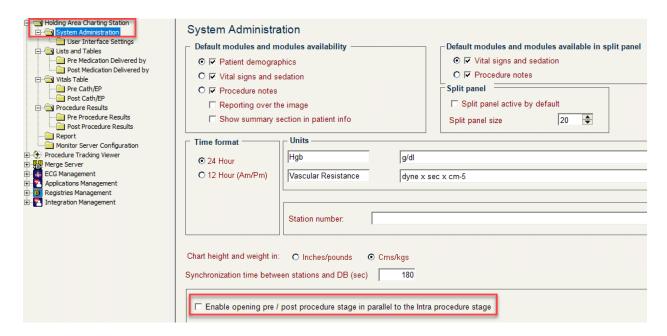
To prevent the issue from occurring, please deactivate the Hemo and HAC Parallel setting in CHMC as illustrated below.

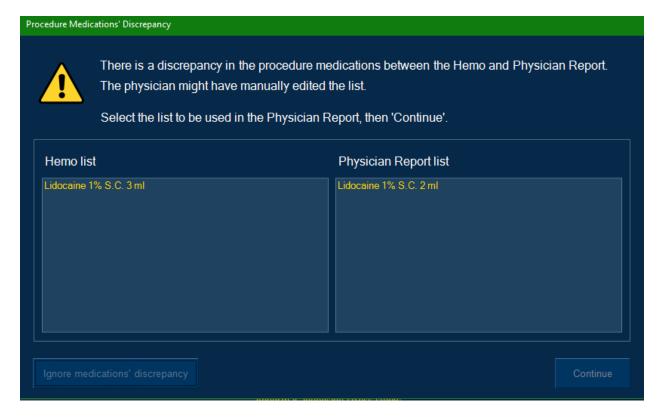
Figure 3 – Discrepancy is reflected in the Medication Discrepancy Tool alert, Hemo list demonstrates the original dose, and the physician list demonstrates the edited dose:

Note: The Medication Discrepancy window enables you to select the desired set of information to be displayed on the physician report. By selecting the Physician Report list which contains the edited dose/correct dose, you are assured that the physician report contains the correct data. However, the Hemo report will still contain the discrepancy.
