DATE: 11<sup>th</sup> August 2026 **FSCA/FSN REF.: APM-26-06129**

**URGENT: FIELD SAFETY NOTICE (FSN)**  
**ForeSight Oximeter cable**

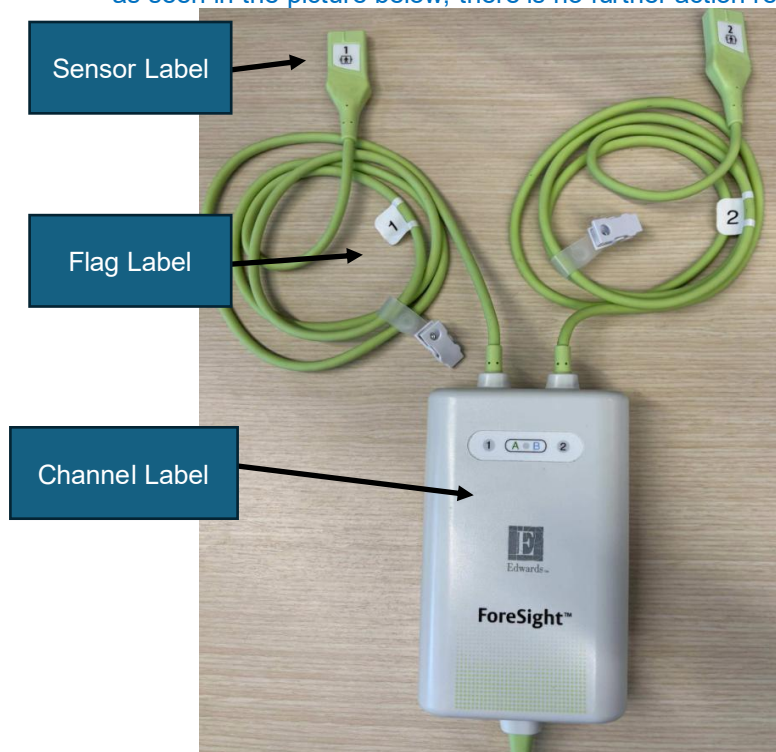
Based on customer feedback, BD has identified that during manufacturing, the laterality identification labels may be missing or inaccurately placed on the device. There is potential that the labels on the green cables may have been switched, with the channel 1 cable labelled as channel 2, and the channel 2 cable labelled as channel 1 [CS4.1][KL4.2]. This will lead to a mismatch as to the left and right values displayed on the monitor and what the labels indicate on the cables.

Should this potential issue occur during use, the values displayed on the monitor will be switched and will represent the opposite region

1. Verify for the presence of the flag, sensor, and channel labels on the device.
2. Verify that the flag and sensor labels correspond to the correct channel label (A1 on left / B2 on right) on the housing (See picture below for correct label placement).
3. If either of the labels are missing, or the flag label and/or the sensor label do not match the channel label on the housing, quarantine the device and return the completed response form to BD at [BDFieldActions@bd.com](mailto:BDFieldActions@bd.com) for BD Technical Services to contact you.
4. If the flag and sensor labels correctly correspond to the channel labels, as seen in the picture below, there is no further action required.
