## **URGENT Field Safety Notice**

### **Philips Azurion and Allura Systems**

Potential loss of imaging functionality (Allura/Azurion), loss of motorized movement (Allura), or loss of data (Allura) due to unauthorized Hard Disk Drives

17-JUN-2026

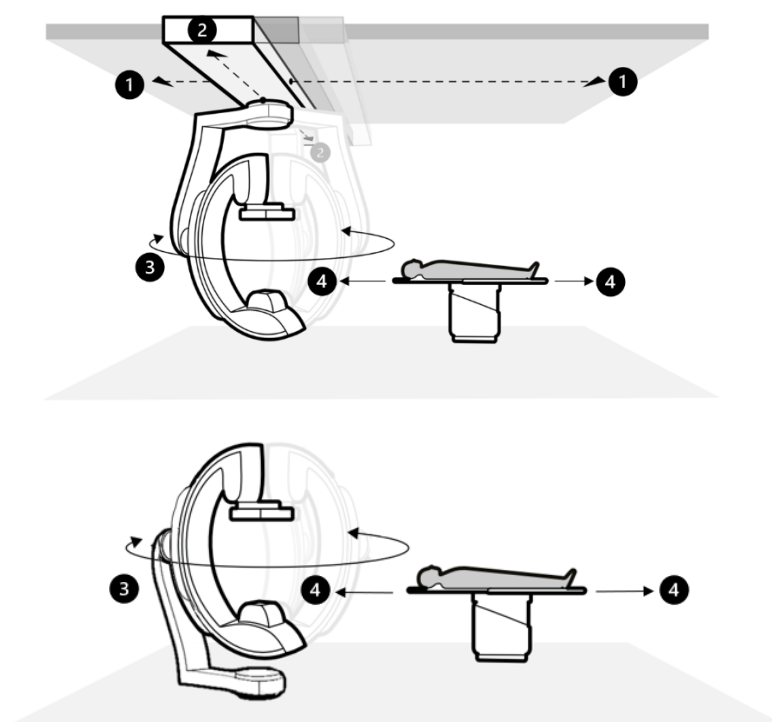
Figure 1 – Manual movements of the ceiling-mounted system (top) and floor-mounted system (bottom)

- Circulate this Urgent Field Safety Notice to all users of the system so that they are aware of the issue and follow the instructions below.
- In case motorized movements are unavailable, the stand can be manually repositioned using the handgrips and brake controls located on both sides of the stand. For ceiling-mounted systems, manual longitudinal (1), transversal (2) and rotational (3) stand movements remain available. Note: Transversal stand movements (2) are only available for ceiling-mounted systems with the FlexMove option. For floor-mounted systems, only rotational (3) stand movements remain available. The table longitudinal position (4) can be adjusted manually, when the table is not tilted (see Figure 1 below).

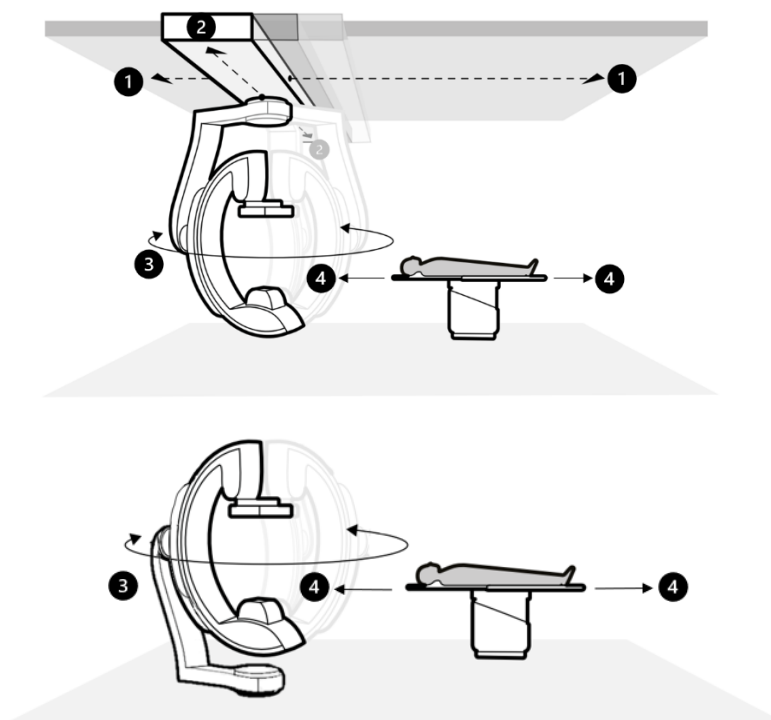
Figure 1 – Manual movements of the ceiling-mounted system (top) and floor-mounted system (bottom)

- Circulate this Urgent Field Safety Notice to all users of the system so that they are aware of the issue and follow the instructions below.
- In case motorized movements are unavailable, the stand can be manually repositioned using the handgrips and brake controls located on both sides of the stand. For ceiling-mounted systems, manual longitudinal (1), transversal (2) and rotational (3) stand movements remain available. Note: Transversal stand movements (2) are only available for ceiling-mounted systems with the FlexMove option. For floor-mounted systems, only rotational (3) stand movements remain available. The table longitudinal position (4) can be adjusted manually, when the table is not tilted (see Figure 1 below).
