## Field Safety Notice

Magnetic Resonance (MR) imaging systems with Diffusion Tensor Imaging (DTI)  
Incorrect data in Enhanced MR DICOM Export

September 2026

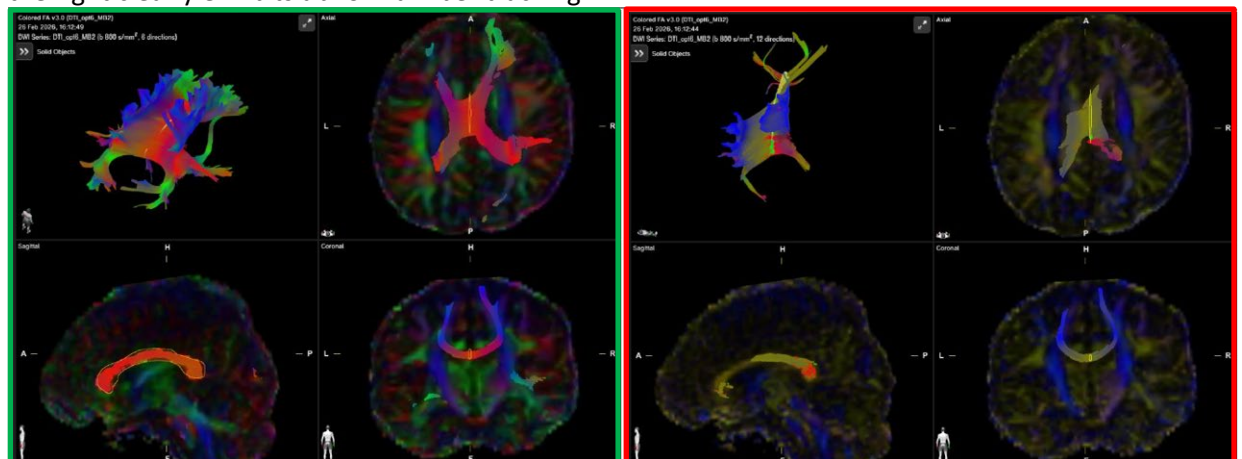
When exporting diffusion tensor imaging (DTI) scans from a Philips MR system using the Enhanced MR DICOM format, the exports contain incorrect data (diffusion directions). If the Enhanced MR DICOM export is used in conjunction with third-party software for tractography (e.g. for mapping nerve fiber pathways in the brain), the software will not be able to correctly process the DTI data for reconstruction (see Figure 1).

Figure 1. Example of a correct reconstruction image (Left) and an incorrect reconstruction image (Right) resulting from processing an Enhanced MR DICOM export with incorrect data. The image on the right clearly exhibits abnormal fiber tracking.

If an incorrect reconstruction image is used for treatment planning, it may lead to inadequate or inappropriate treatment. A surgical procedure planned with incorrect data could result in injury to

- To prevent the issue from occurring while Philips is developing the software solution, use the Classic DICOM transfer option for exporting DTI scans (see instructions below).
  - Open the **DICOM Configuration**, click **Settings and Tools (F10)**

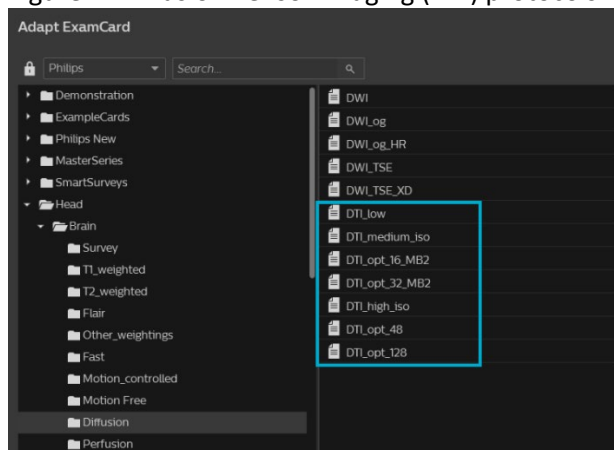
Figure 2. Diffusion Tensor Imaging (DTI) protocols

To identify if your system has Diffusion Tensor Imaging (DTI), navigate to the **Philips\Head\Brain\Diffusion** folder within the Philips protocol database and verify if your system contains the protocols shown in Figure 2.
